September 24, 2024

Terrence Williams, General Manager

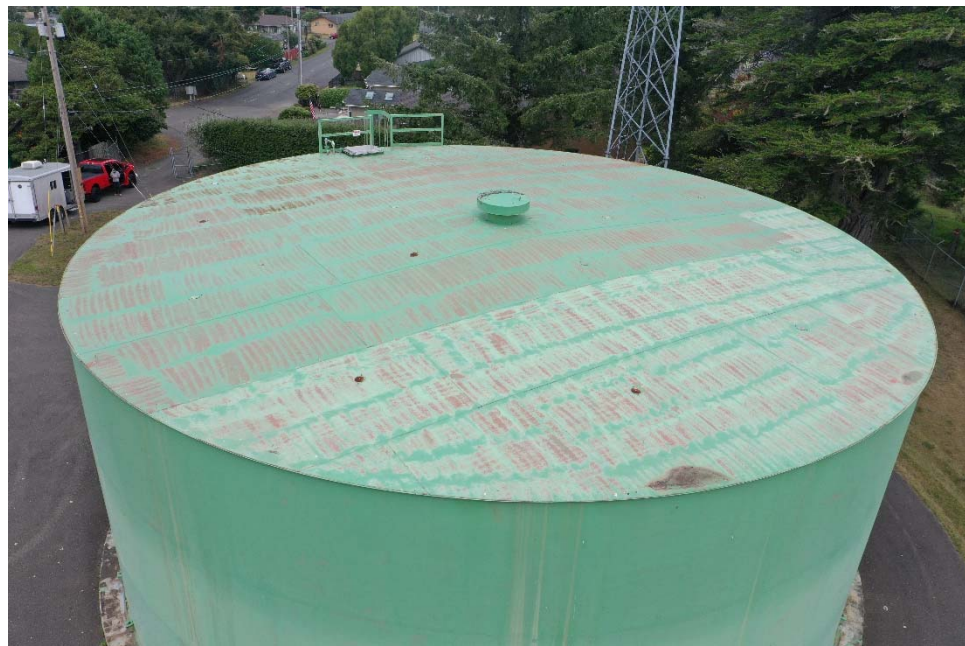
E-3 View of the center vent, illustrating moderate corrosion on the vent cover and nuts and bolts and moss growing on the cover.

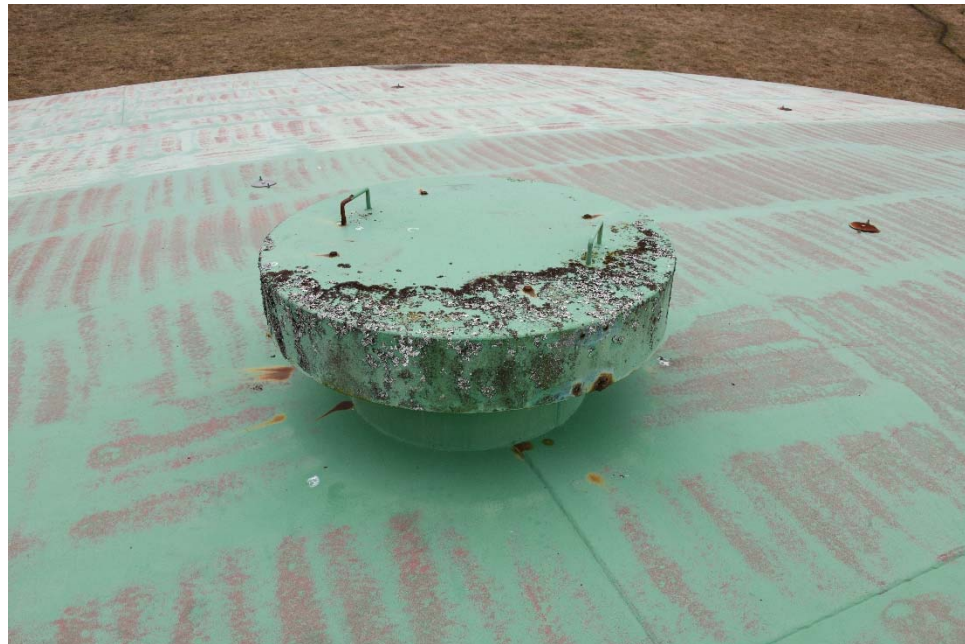
E-4 View of the underside of the center vent cover, illustrating minor to moderate corrosion on the vent cover, neck, and screening. Note failing tape securing the vent screen.

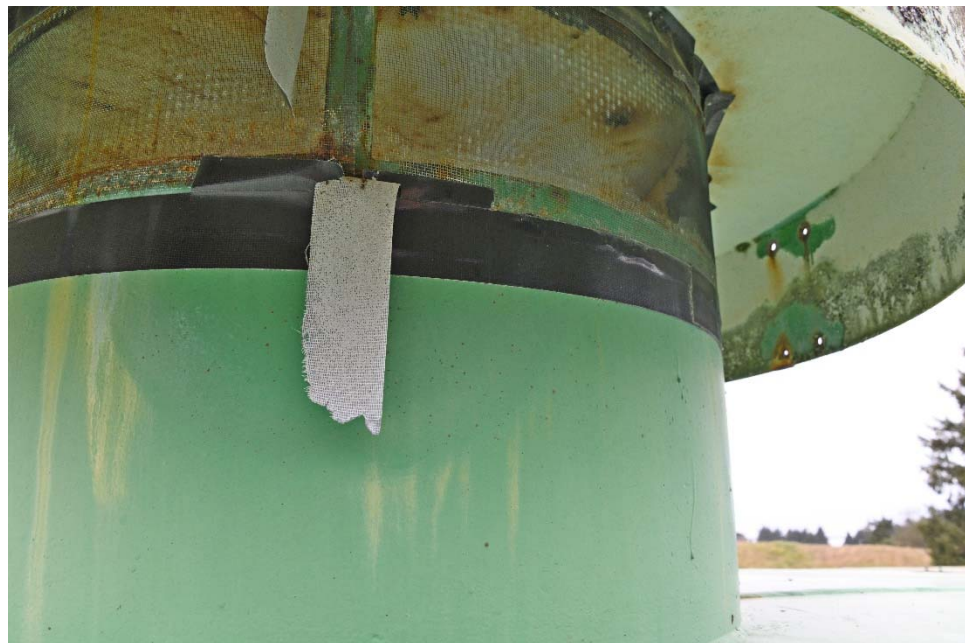
E-5 View of a portion of the roof, illustrating severe oxidation and fading of the paint system with exposed prime coat. Note pattern of exposed prime coat.

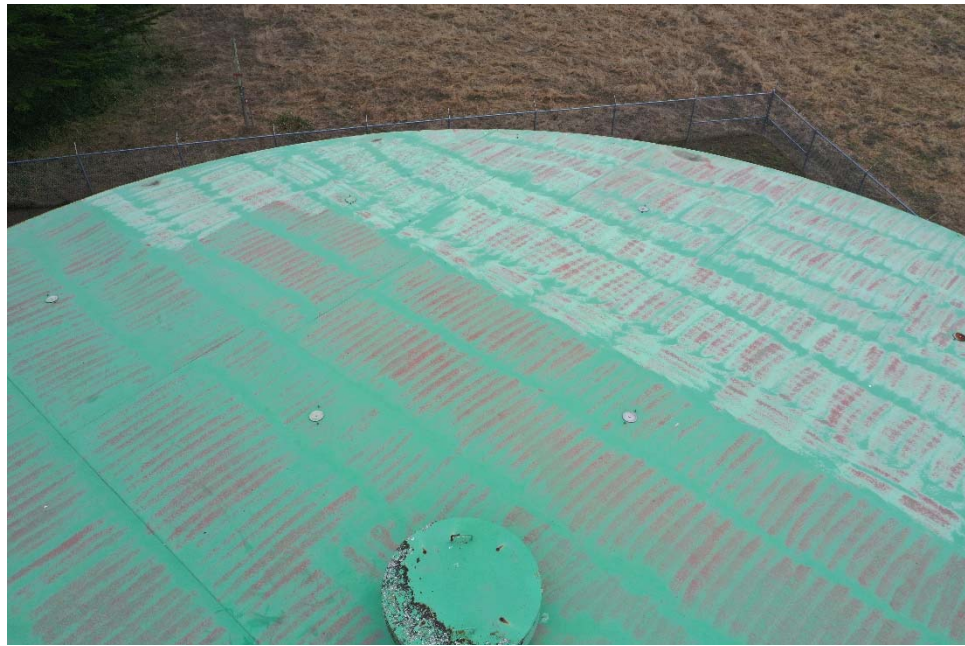
E-6 Same as Photo E-5, except in a different location. Note general corrosion on the handhole covers.

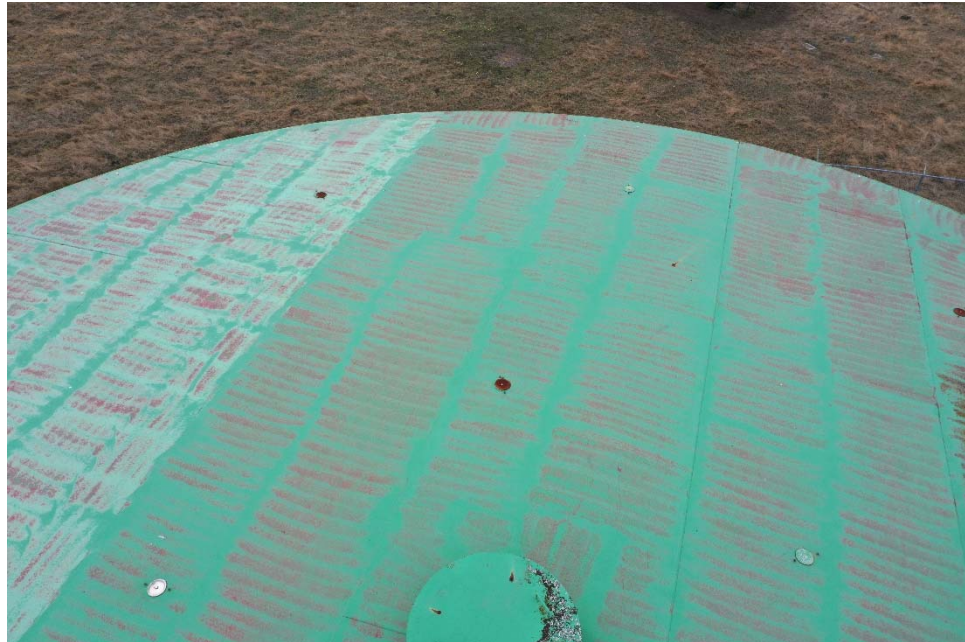
E-7 View of a cathodic protection (CP) handhole cover, illustrating general corrosion on the cover and along the circumference of the handhole.

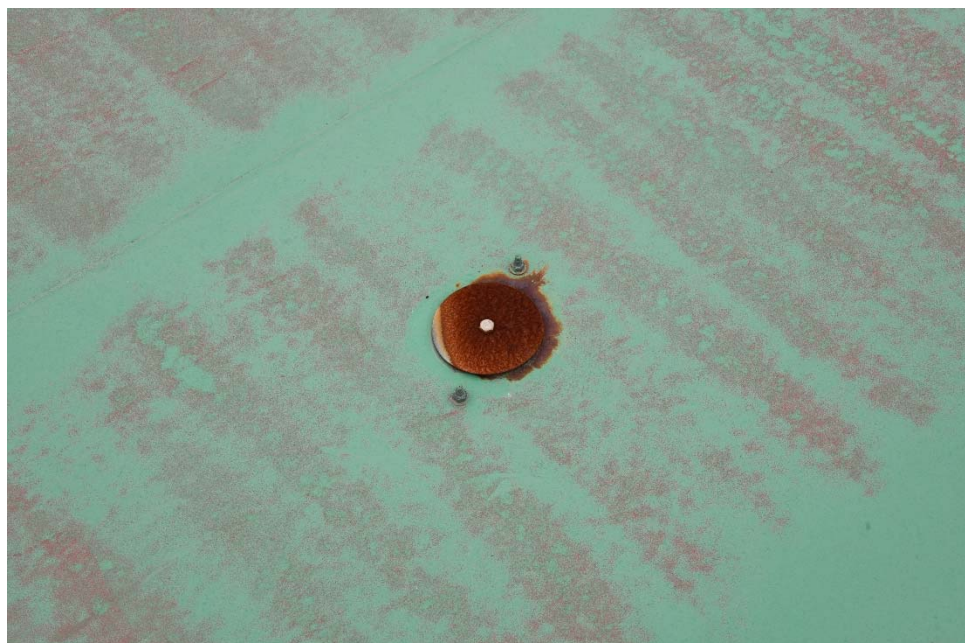
E-8 Close-up view of the roof, illustrating a spot of cracked paint with moderate corrosion.

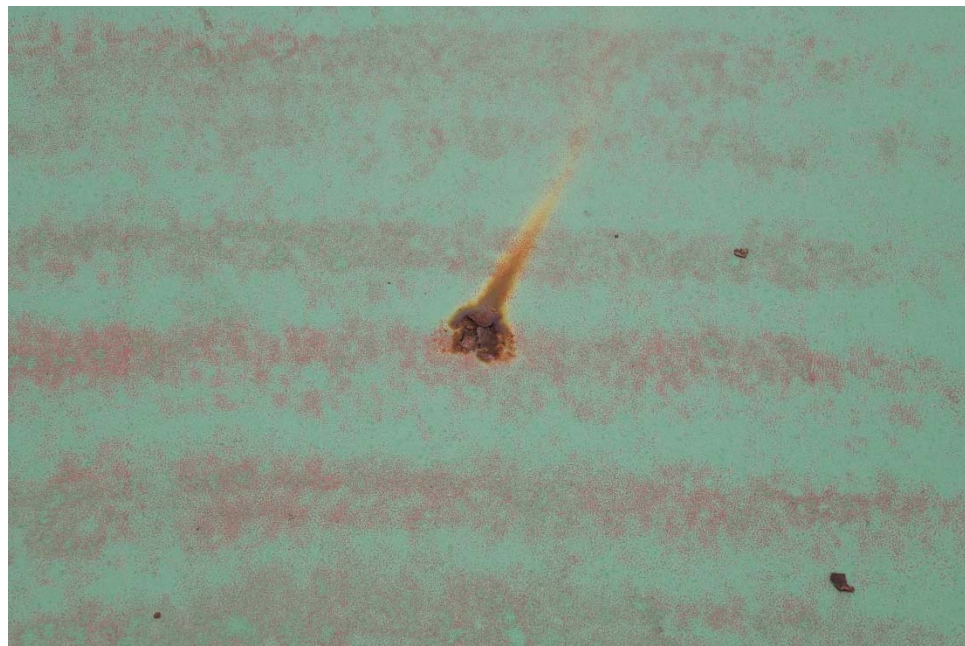
E-9 View of the edge of the roof, illustrating an area of dirt collecting at the edge of the roof with delaminating paint along the edges of the low area.

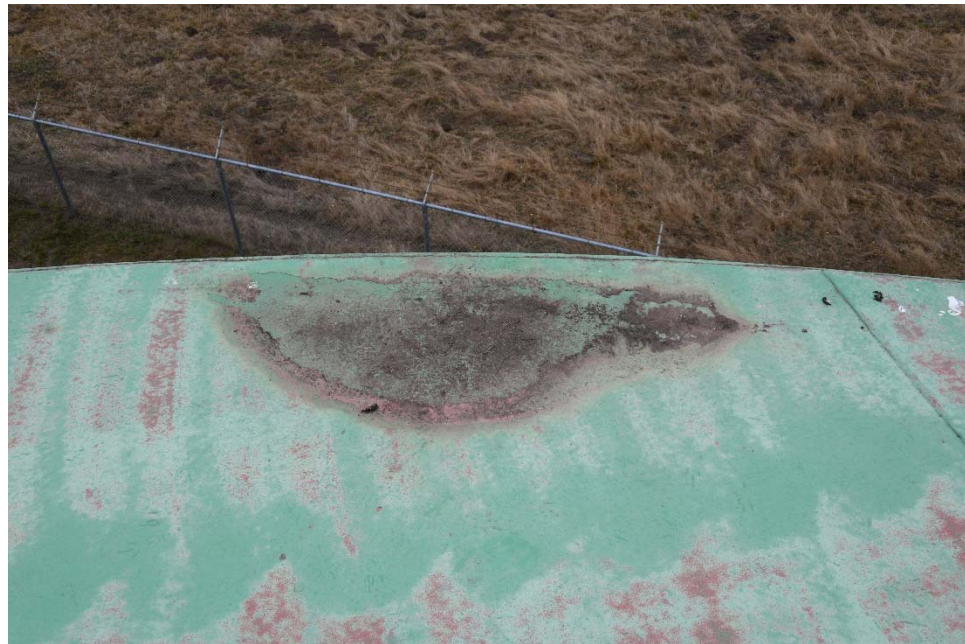
E-10 View of the roof hatch/work area, illustrating general corrosion and moss growing on the guardrail.

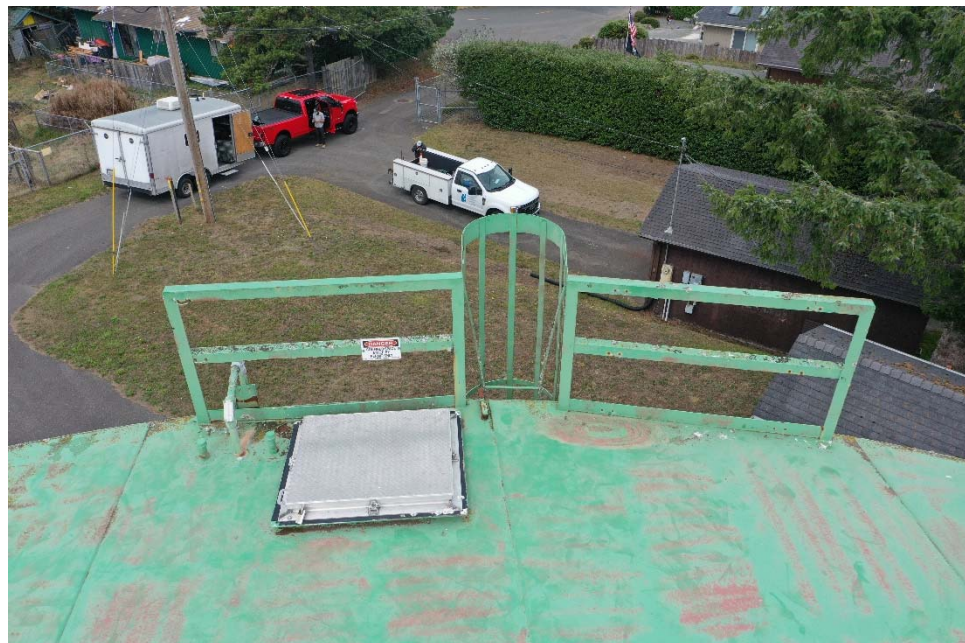
E-11 Same as Photo E-10, except a closer view of the guardrail.

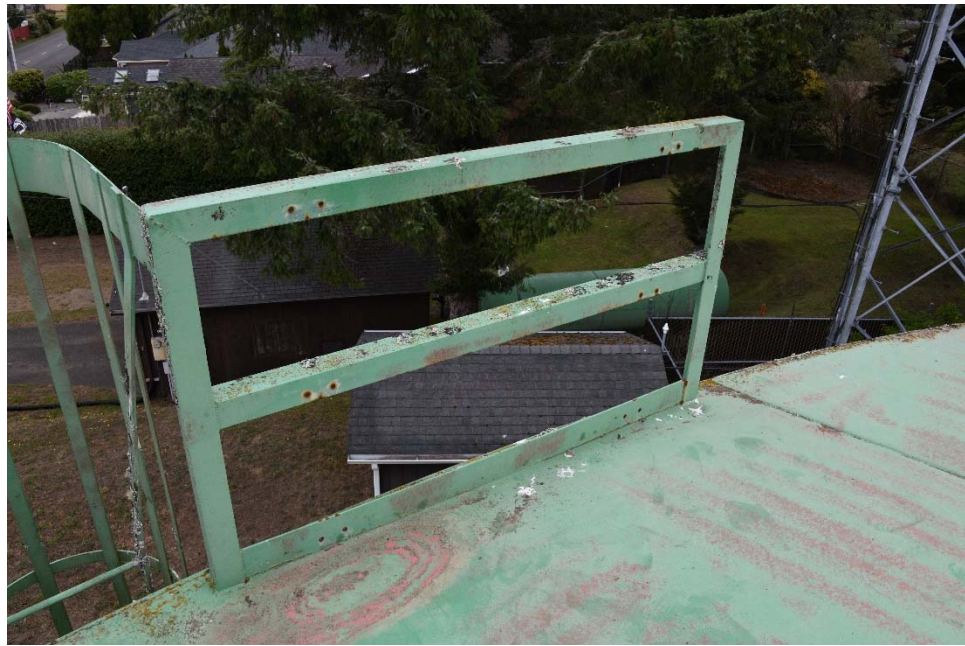
E-12 View of the roof hatch, illustrating minor corrosion along the perimeter of the interior of the hatch curb and good condition of the aluminum cover.

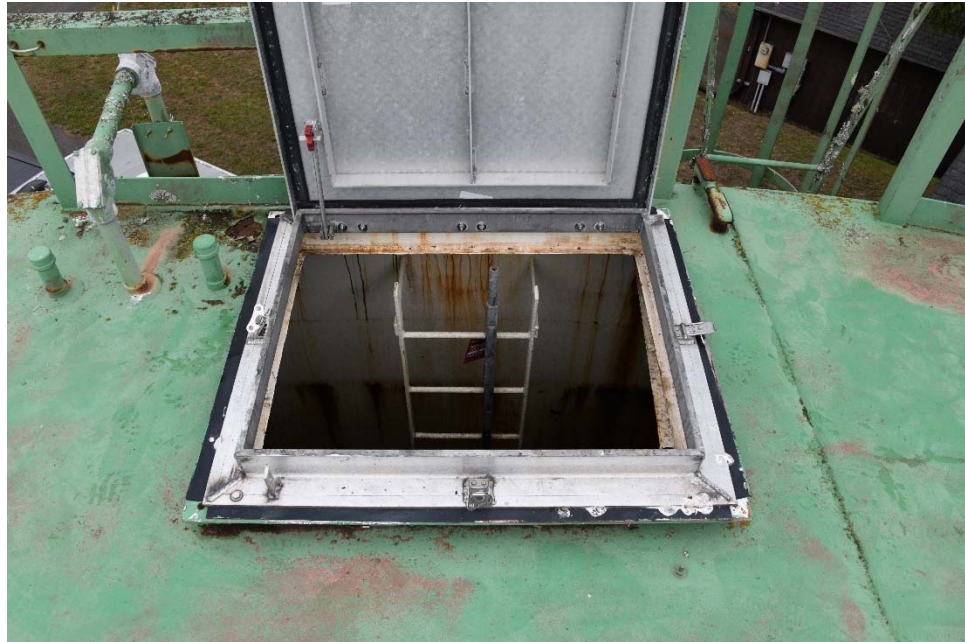
E-13 View of the top of the ladder, illustrating exposed prime coat on the ladder cage.

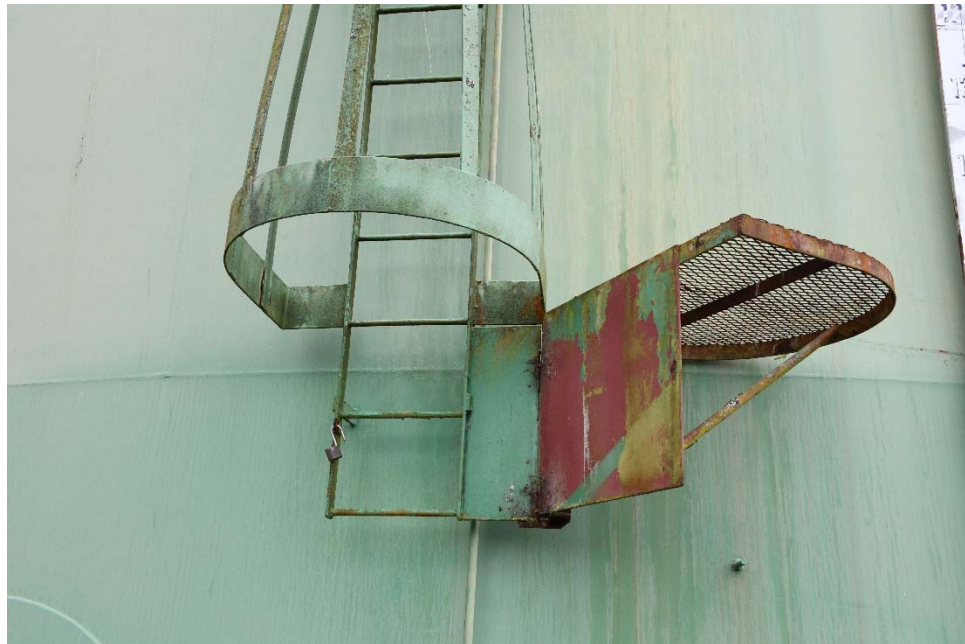
E-16 View of the top of the shell, illustrating moss growing under the top angle and otherwise generally good condition of the paint system.

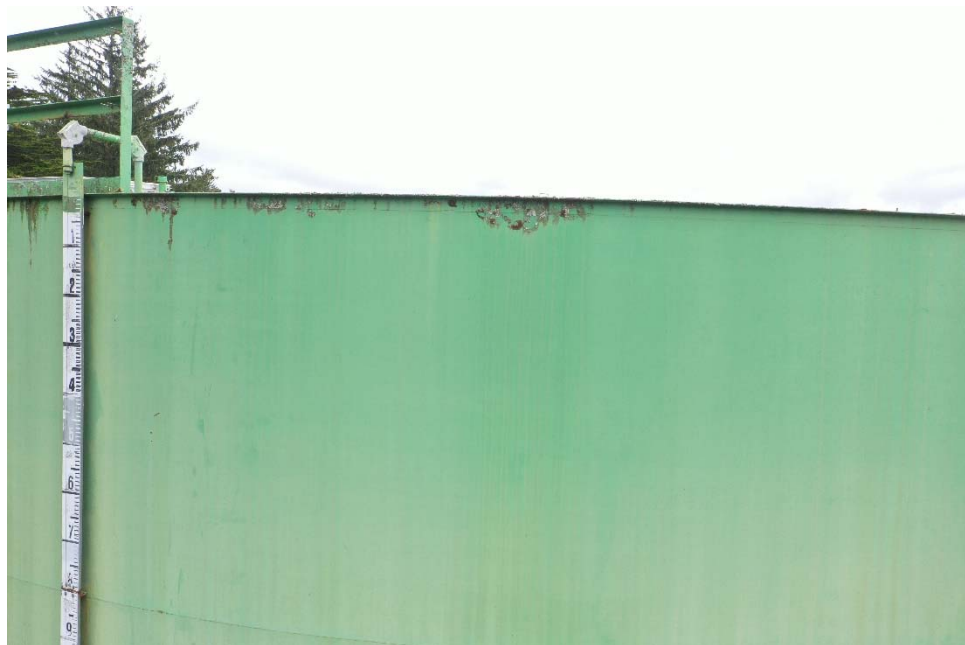
E-17 View of the shell, illustrating moderate oxidation and fading and otherwise good condition of the paint system.

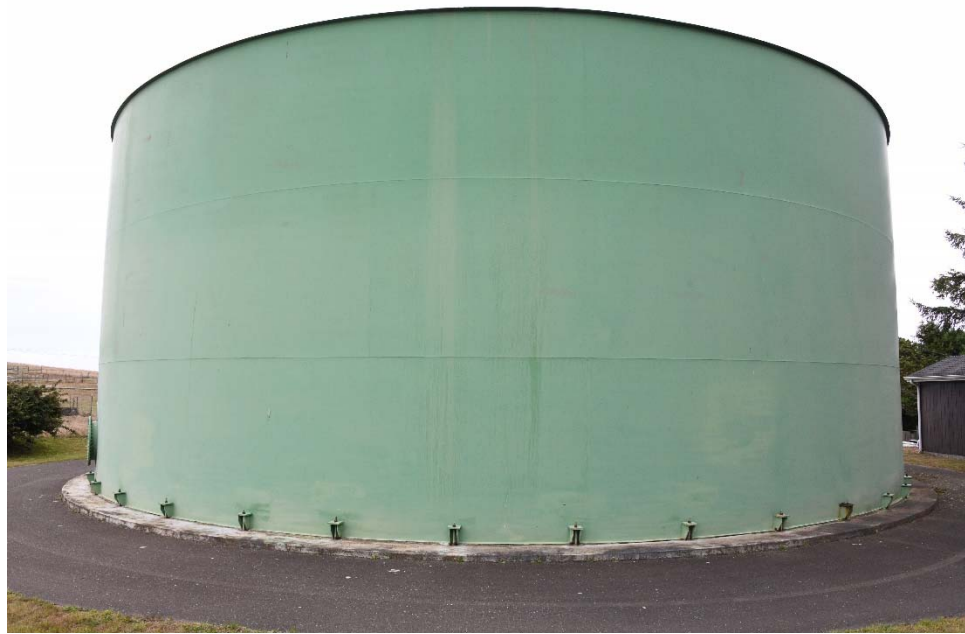
E-18 Same as Photo E-17, except in a different location. Note light color of the topcoats in this area.

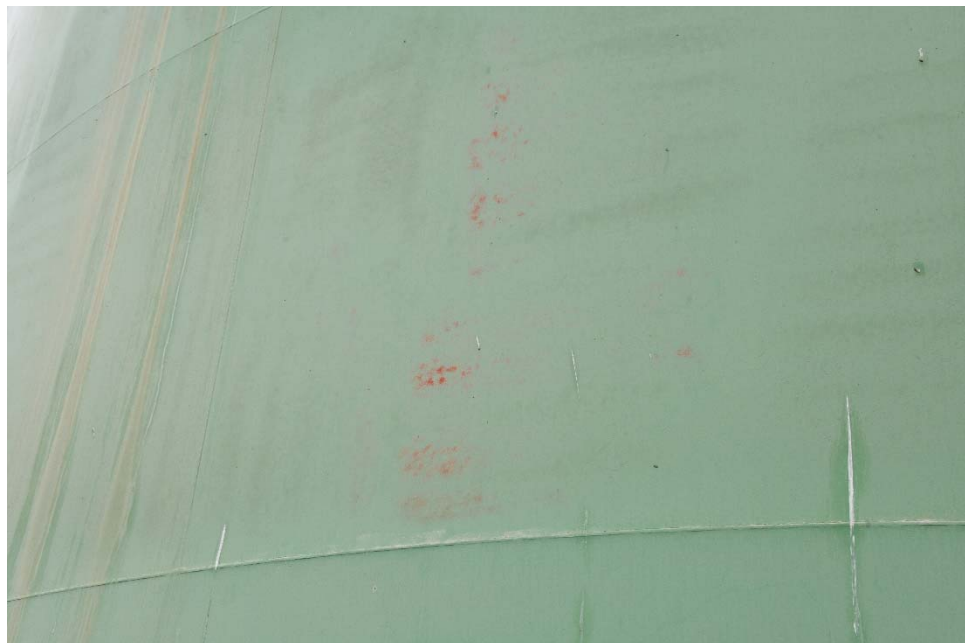
E-20 View of the primary manhole, illustrating moderate corrosion at the nuts and bolts, hinge, and the surface where the identification plate was previously mounted.

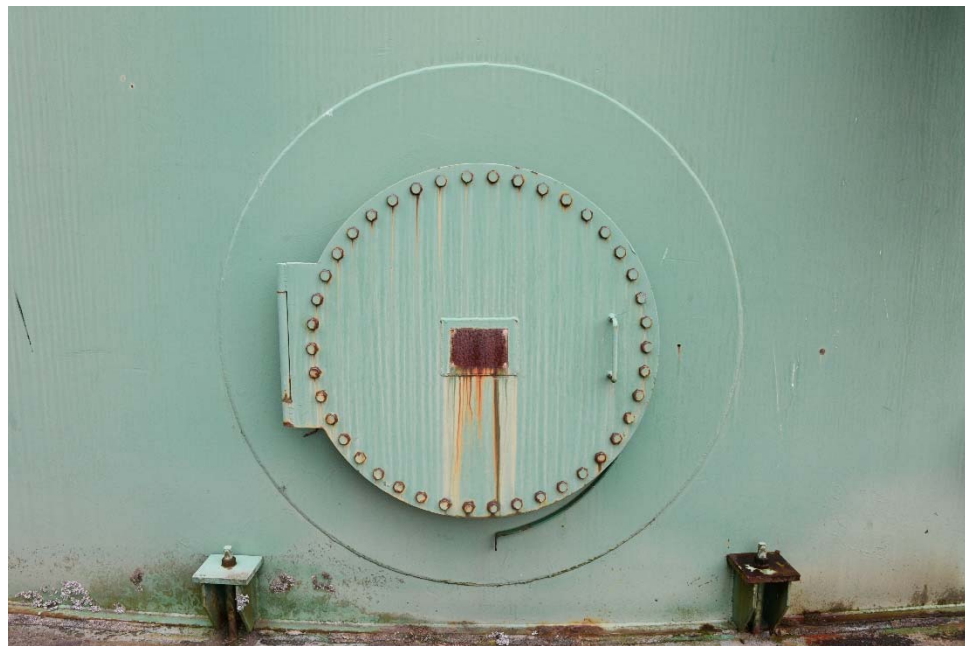
E-21 Same as Photo E-20, except at the other manhole.

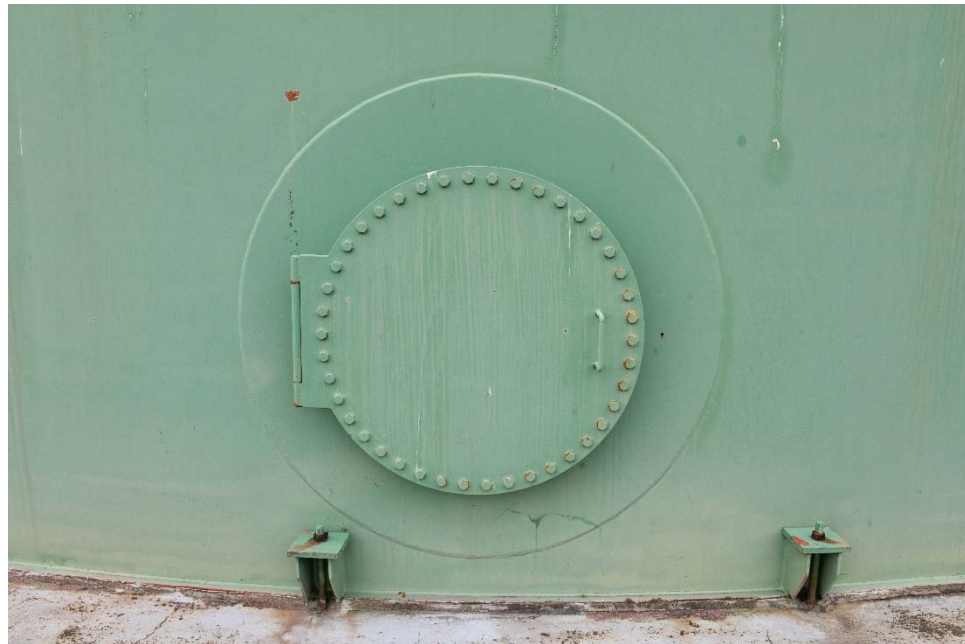
E-22 View of an abandoned bracket on the shell, illustrating moderate corrosion where the threaded rod meets the shell.

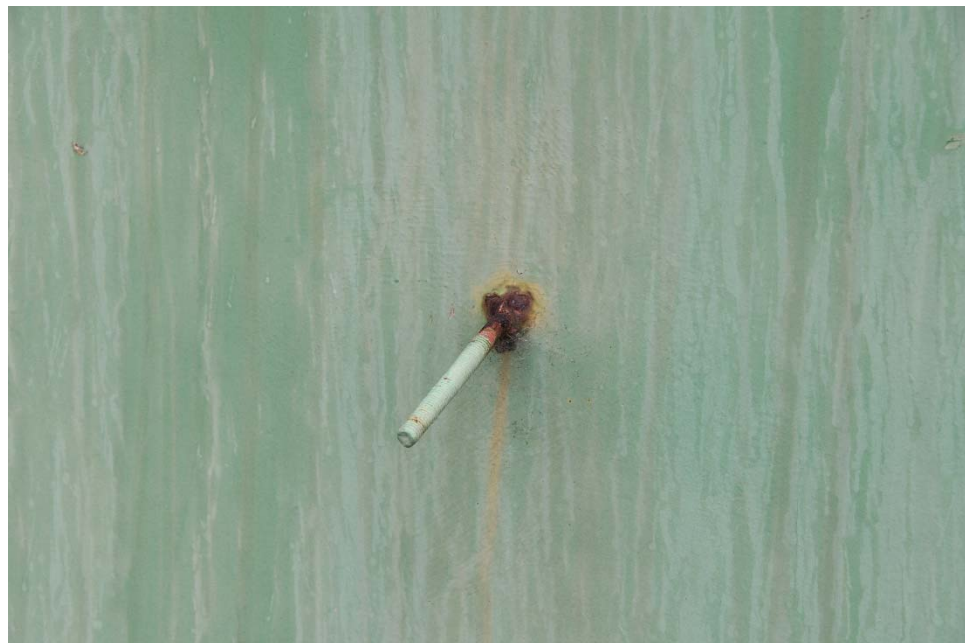
E-23 View of the liquid level indicator gauge board, illustrating the overall poor condition of the gauge board and target.

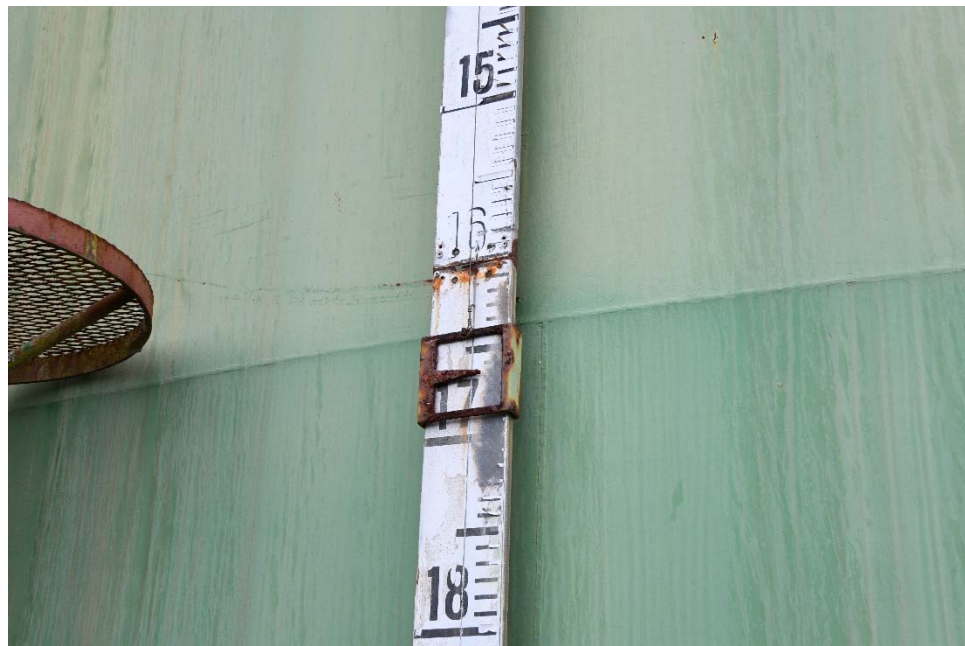
E-24 Same as Photo E-23, except at the bottom of the gauge board. Note severe corrosion at the bottom of the board.

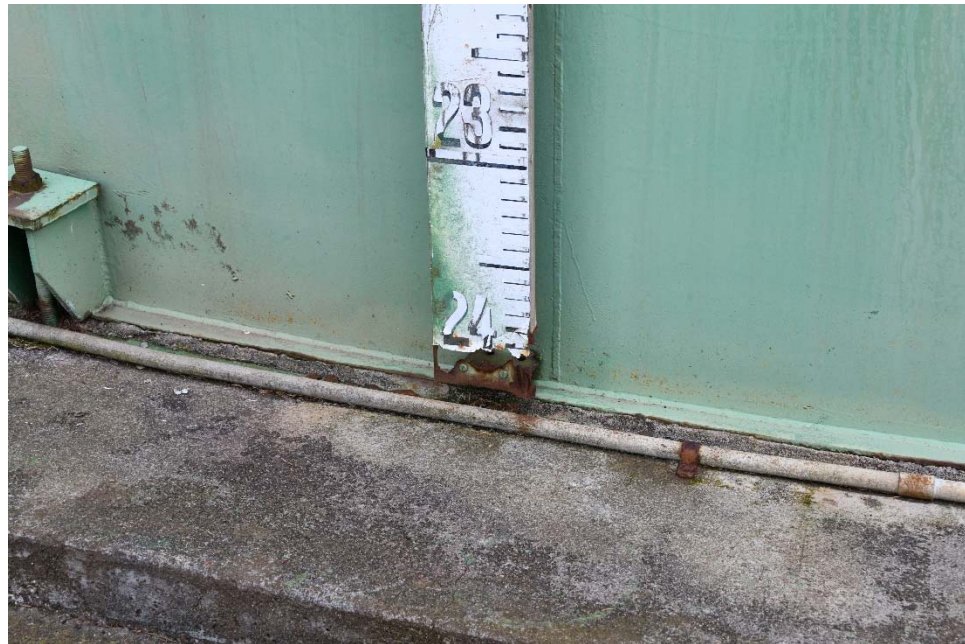
E-25 View of seismic anchor bolts, illustrating moderate corrosion on the nuts and bolts and moss along the lower portion of the shell.

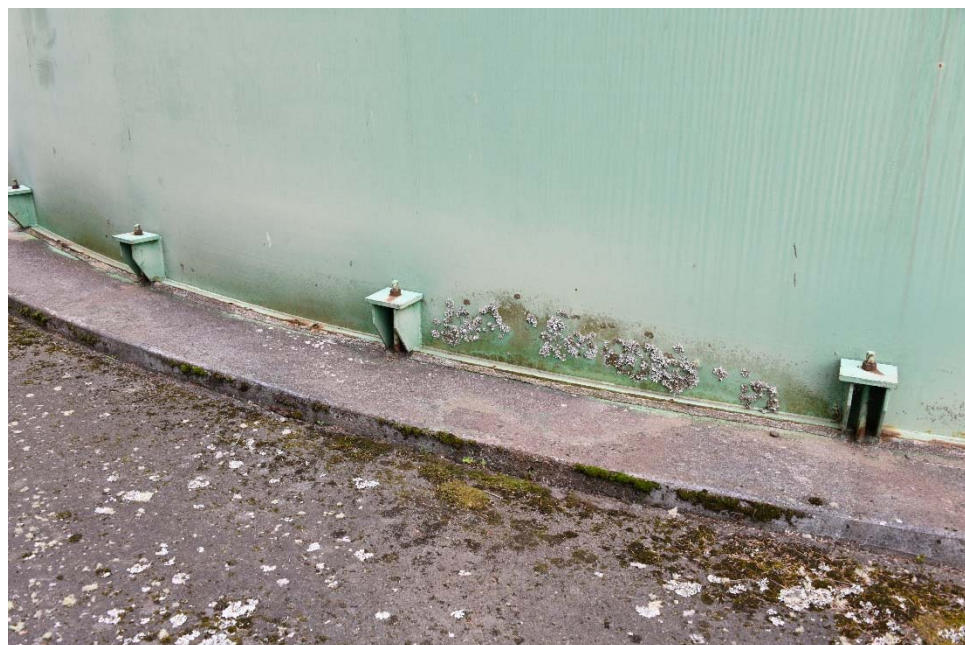
E-26 Same as Photo E-25, except a close-up view of an anchor bolt. Note moderate to severe corrosion with delaminating paint on the anchor chair.

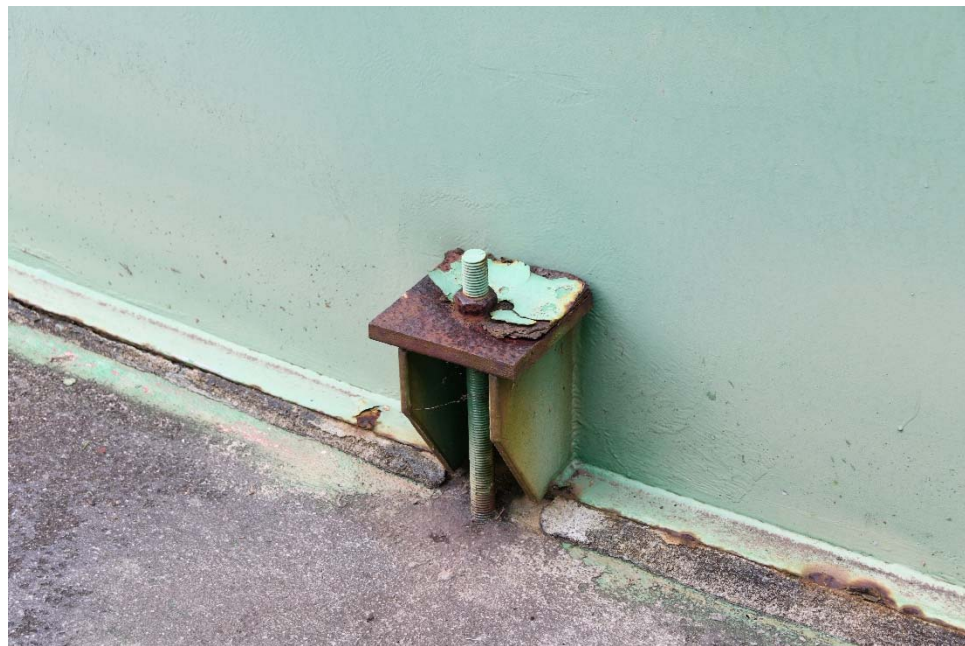
E-27 View of the bottom plate extension (BPE), illustrating moderate to severe corrosion along the edge of the BPE. Note areas where corrosion is encroaching on the shell to BPE weld.

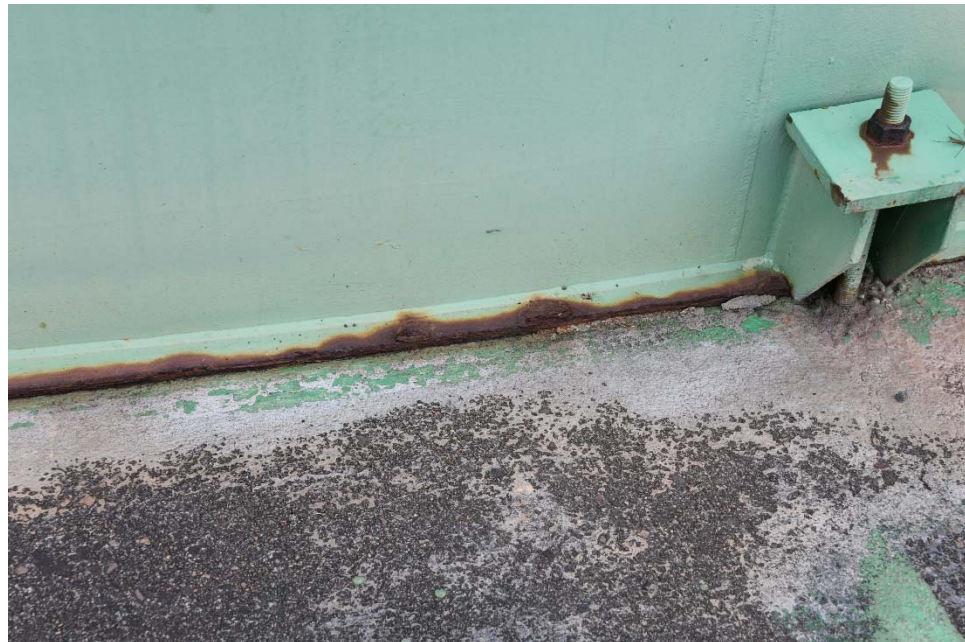
E-28 Same as Photo E-27, except in a different location.

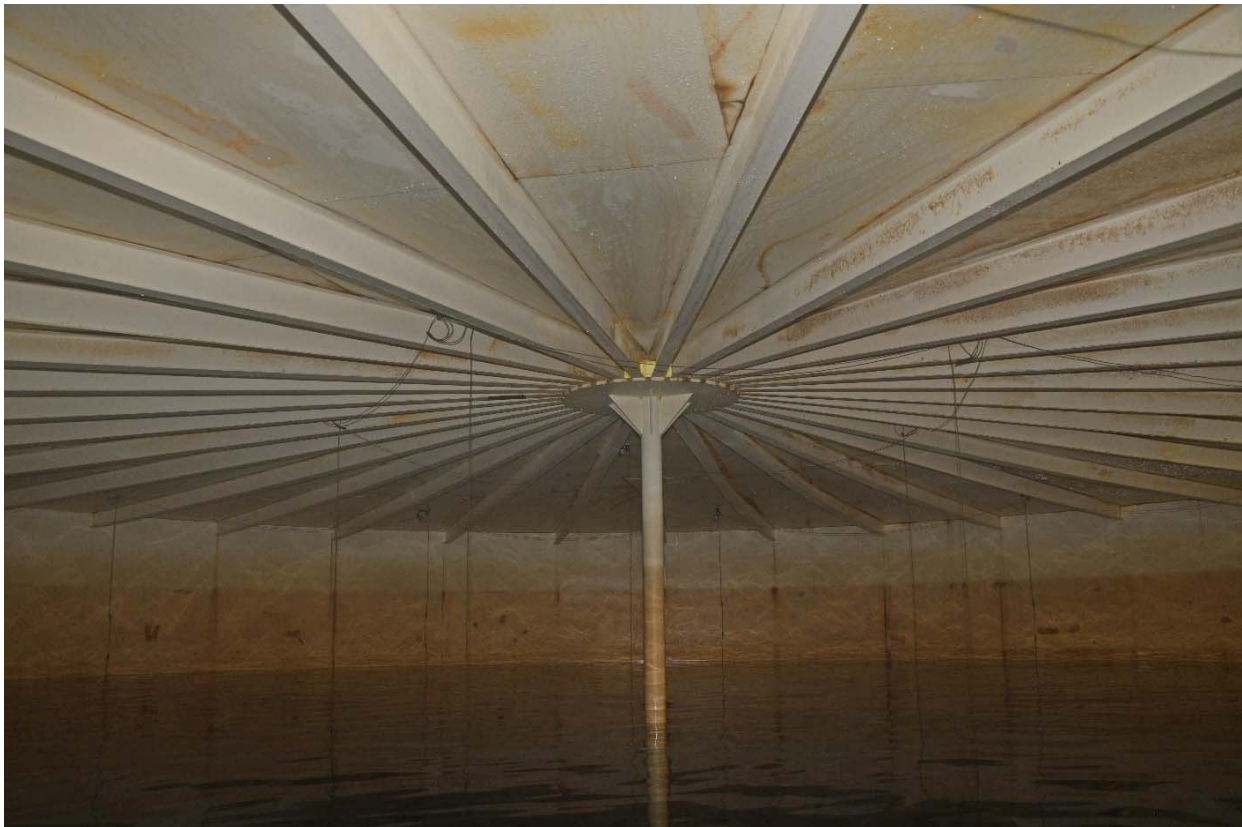
I-2 View of the center support structure, illustrating random minor corrosion on the lower rafter flanges and along the edge of the support plate.

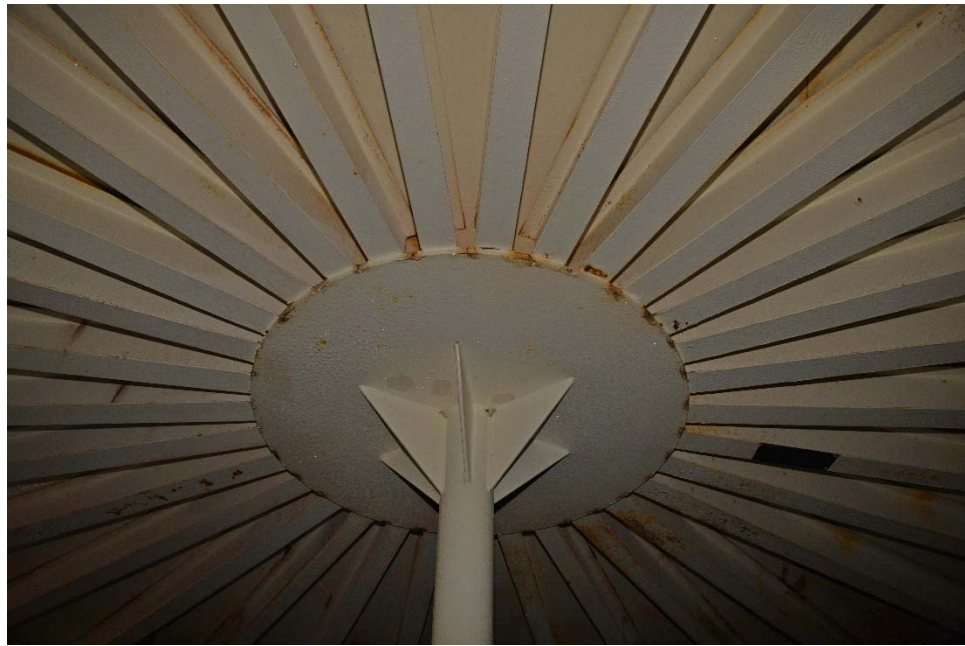
I-3 Same as Photo I-2, except a close-up view of the edge of the support plate.

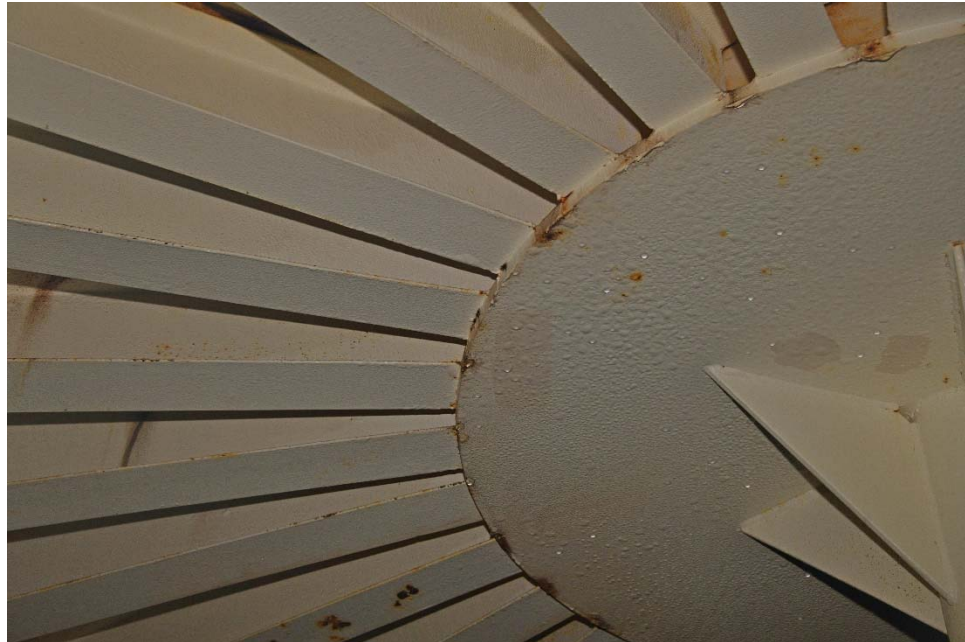
I-4 View of a portion of the roof, illustrating random general corrosion on the roof plates and rafters.

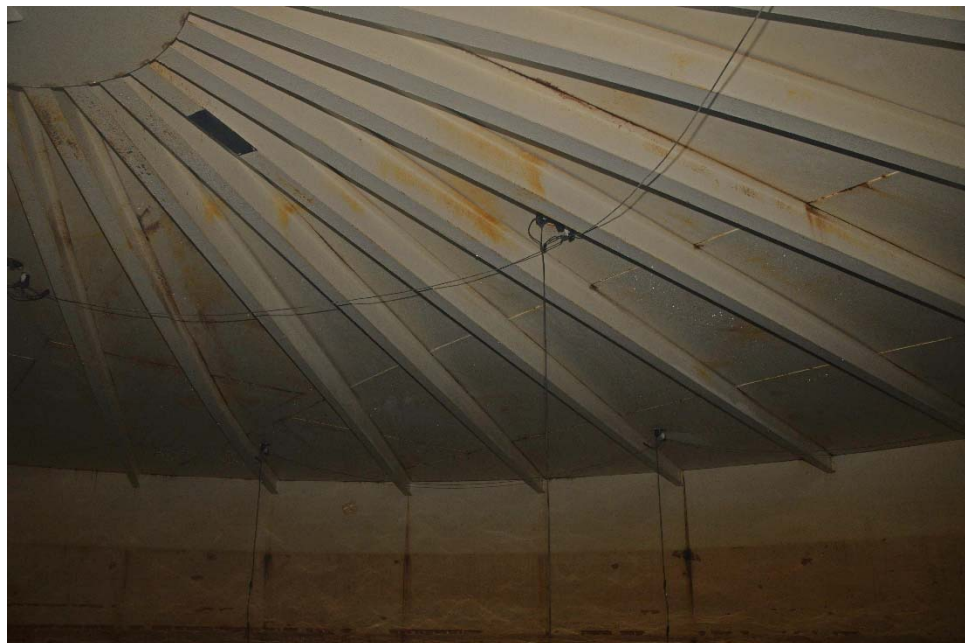
I-5 Same as Photo I-4, except in a different location. Note several rafters have moved from their original location.

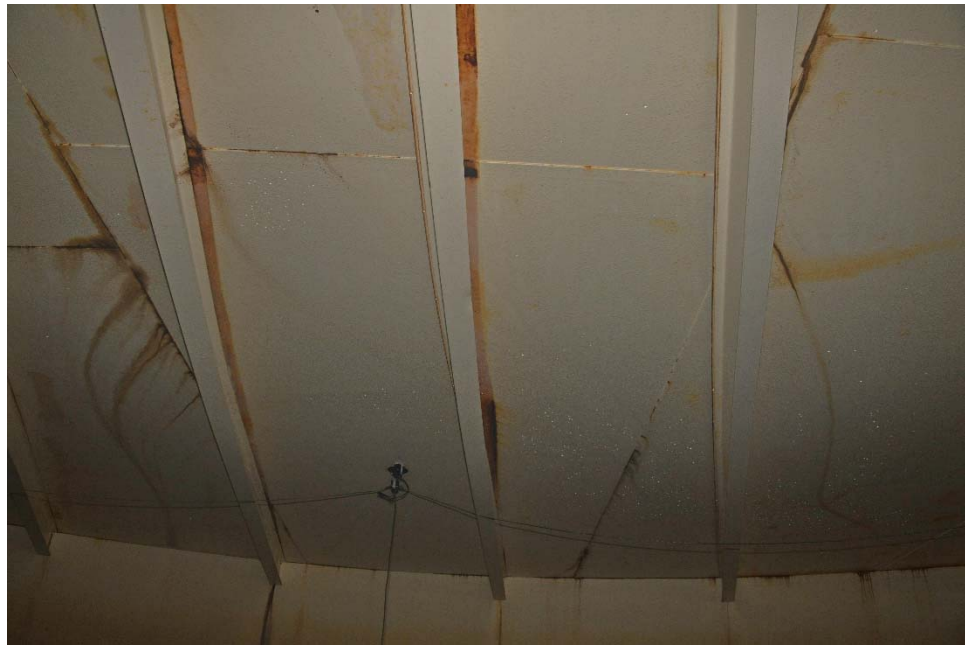
I-9 View of the roof above a rafter, illustrating general corrosion on the roof plates that previously rested on the rafter.

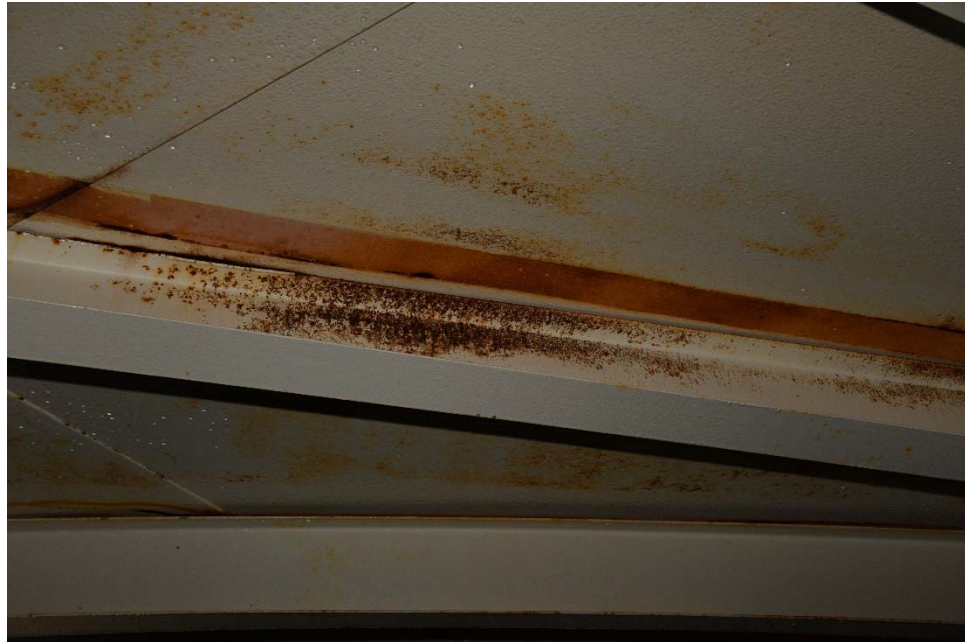
I-10 Same as Photo I-9, except in a different location.

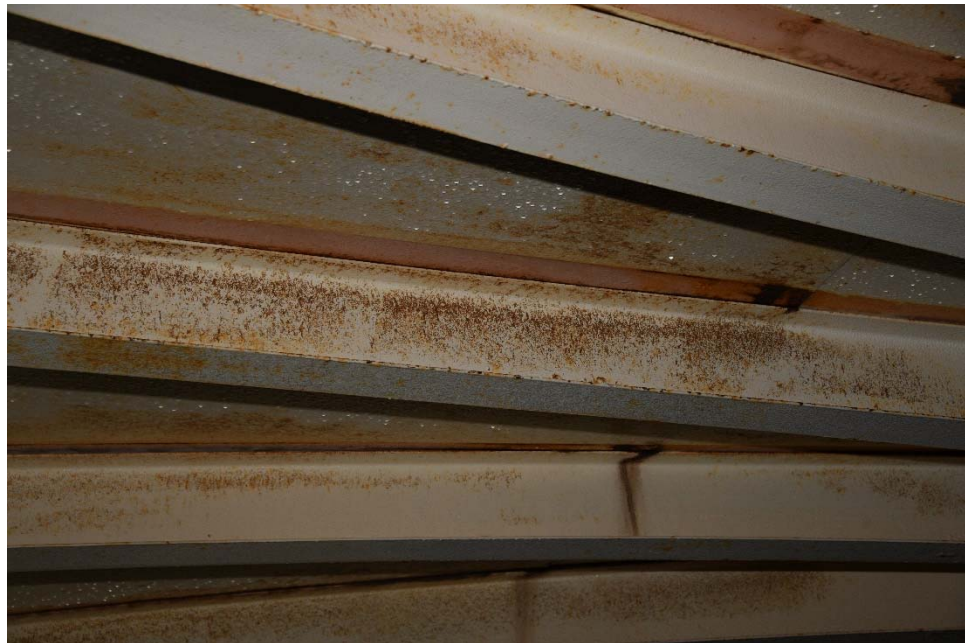
I-11 View of the roof, illustrating general corrosion on the roof plates.

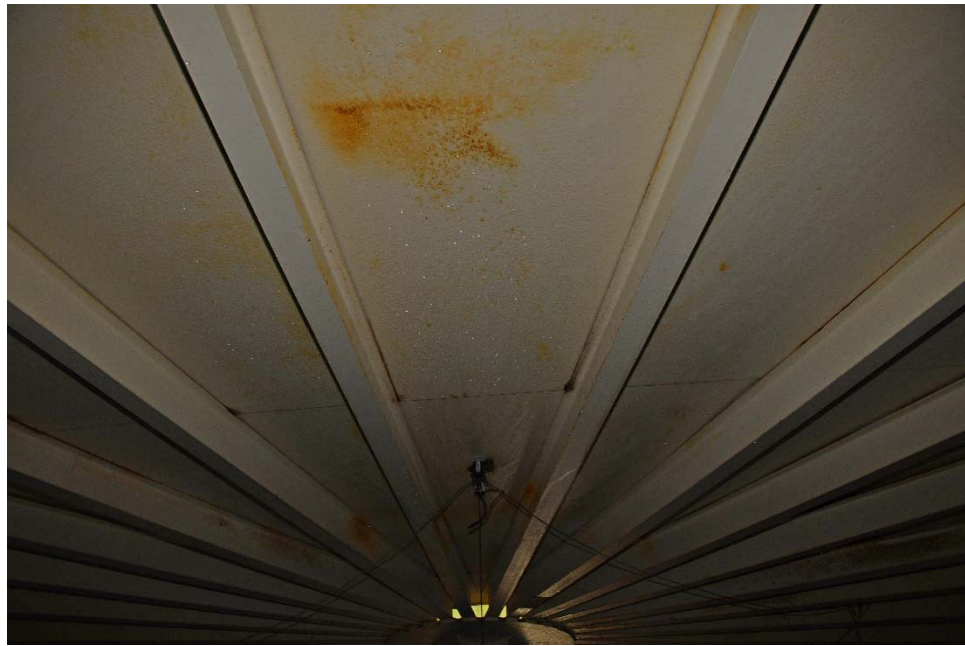
I-12 View of a cathodic protection handhole, illustrating minor corrosion along the circumference of the handhole and oxidation of the adjacent hardware.

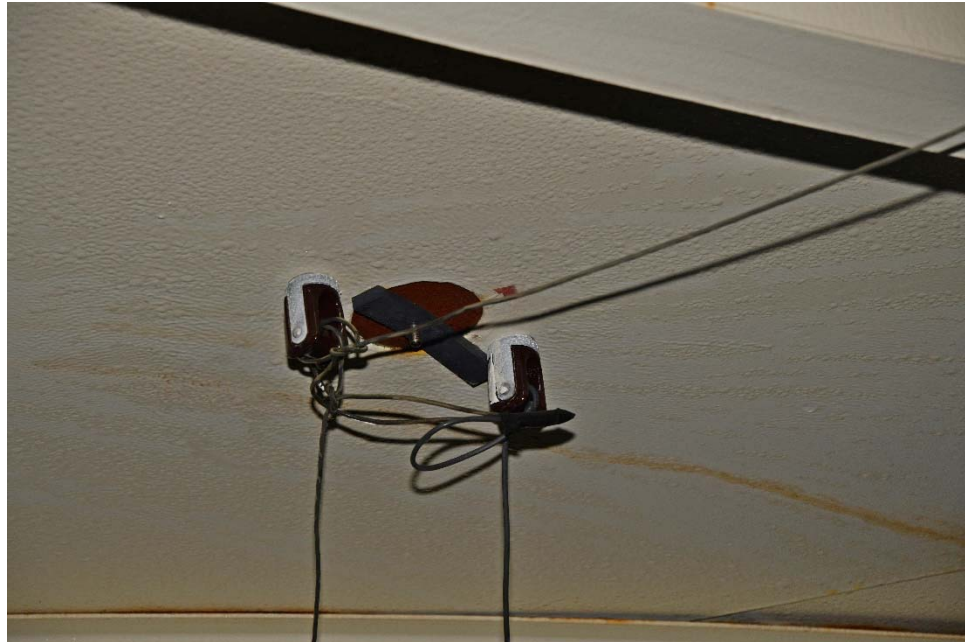
I-13 Same as Photo I-12, except in a different location.

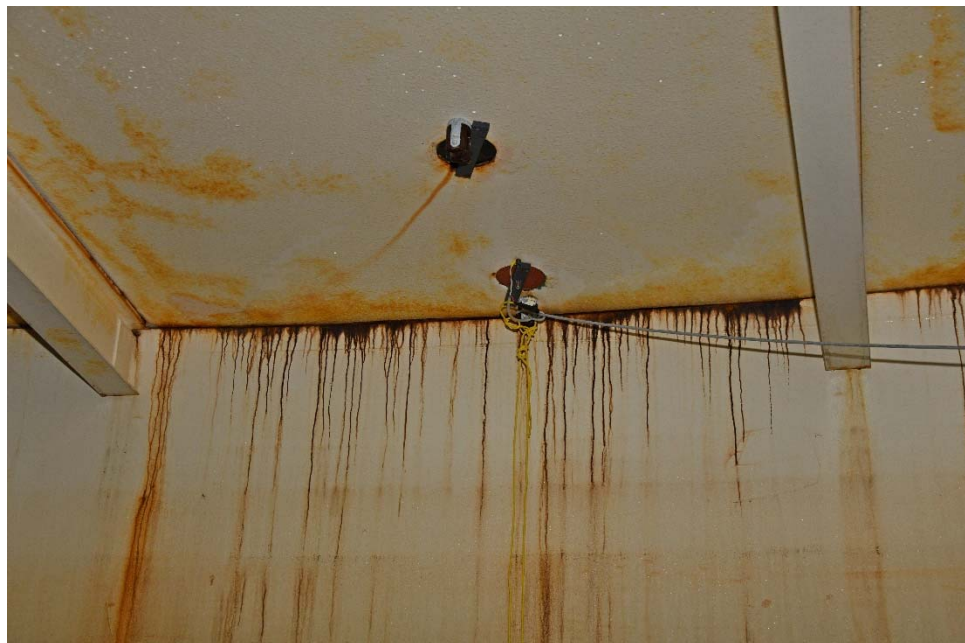
I-14 View of a rafter to shell connection, illustrating minor corrosion along the upper rafter flange and otherwise good condition of the coating system.

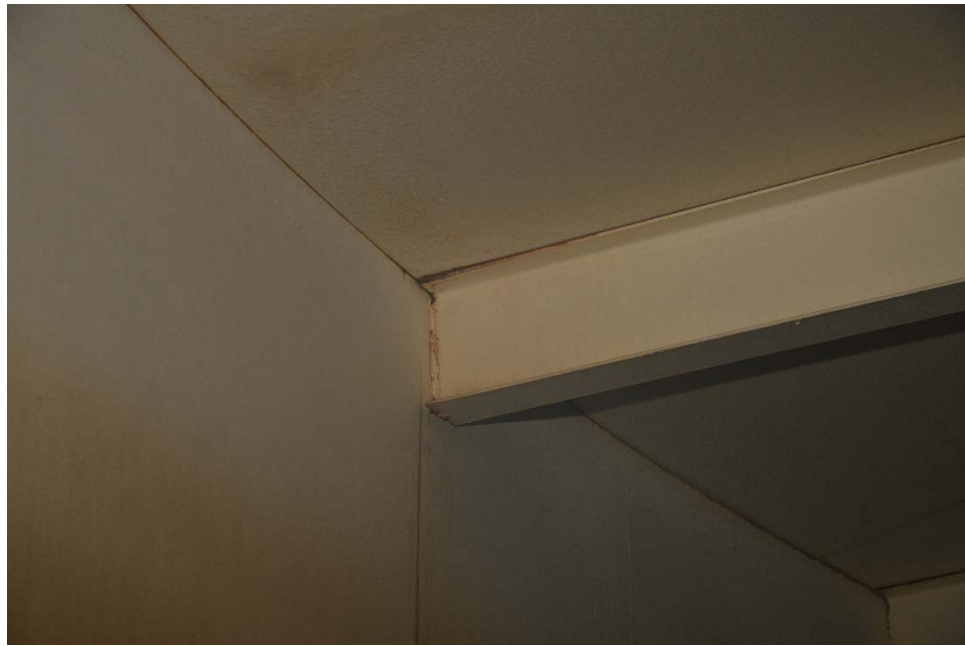
I-15 Same as Photo I-14, except from the opposite side of a different connection.

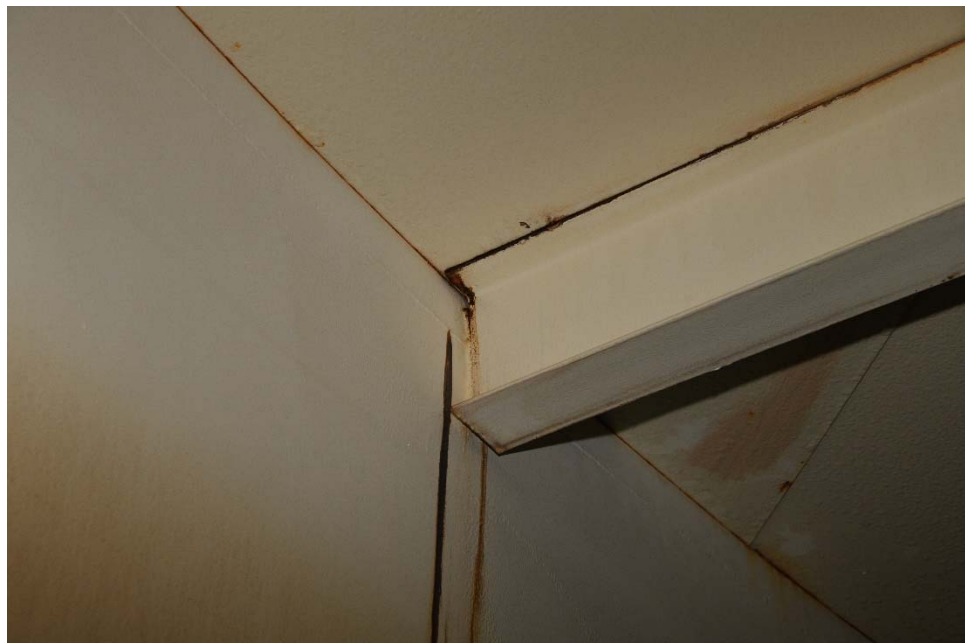
I-17 View of the roof to shell transition, illustrating minor corrosion along the void at the transition.
