September 24, 2024

Terrence Williams, General Manager

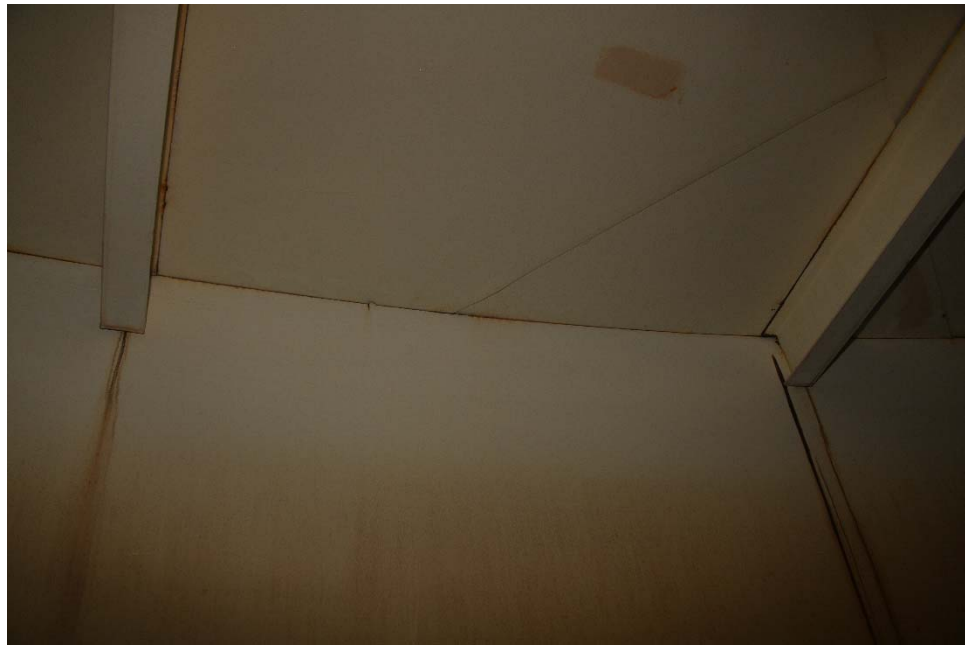
I-18 Same as Photo I-17, except a close-up view of the transition. Note small spot of cracked coating.

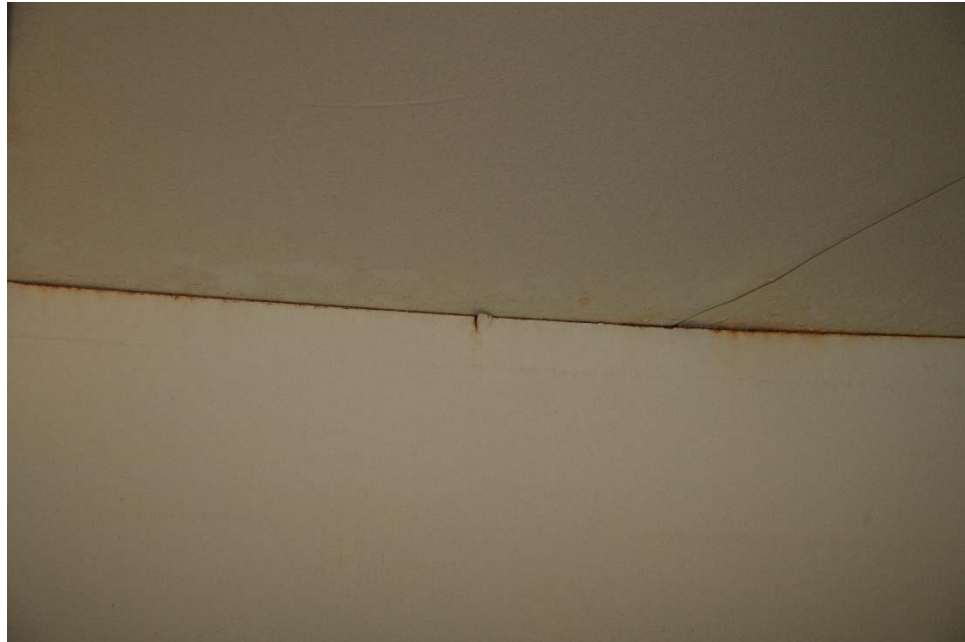
I-19 View of the shell, illustrating staining in the water fluctuation zone and otherwise good condition of the coating system.

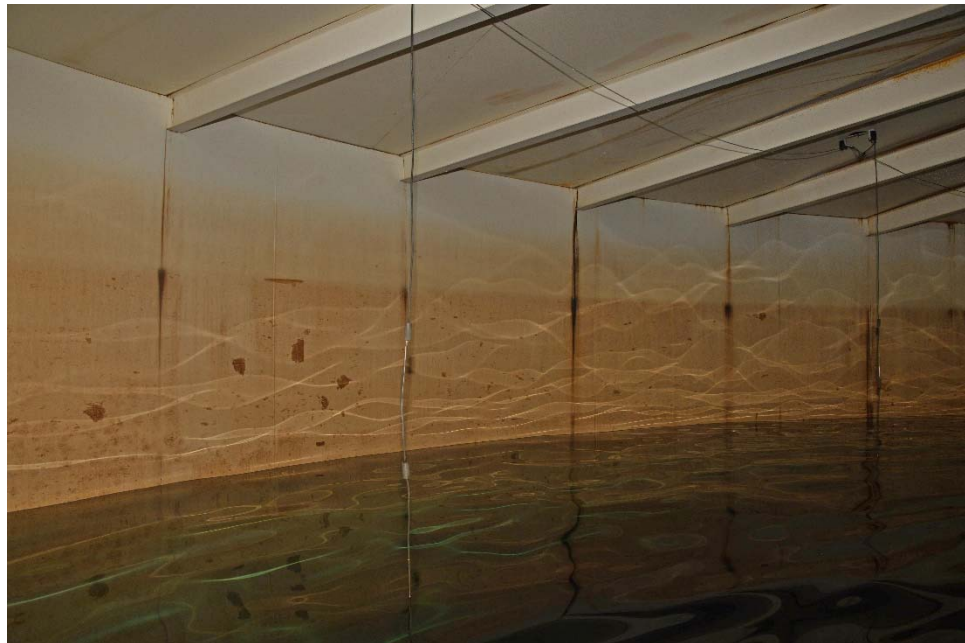
I-20 Same as Photo I-19, except in a different location.

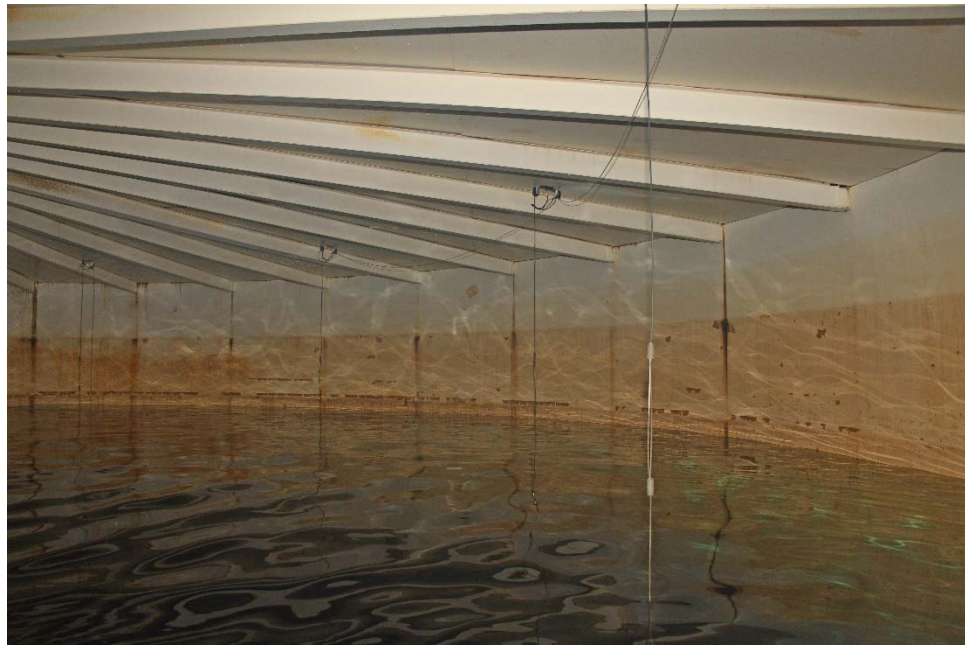
I-21 View of the overflow, illustrating corrosion at the upper flanges and stand-off bracket.

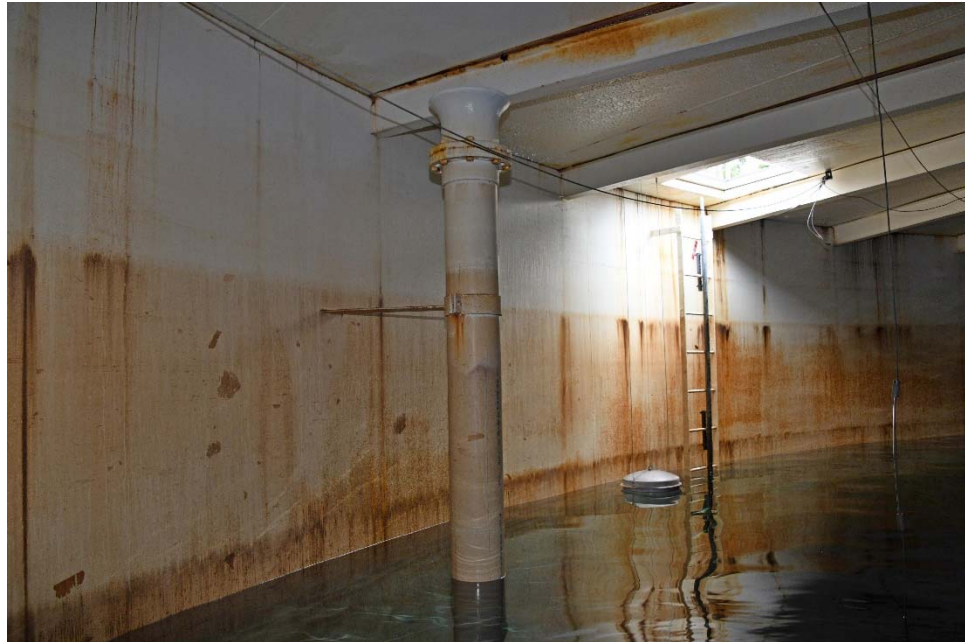
I-22 Same as Photo I-21, except a close-up view of the upper flanges.

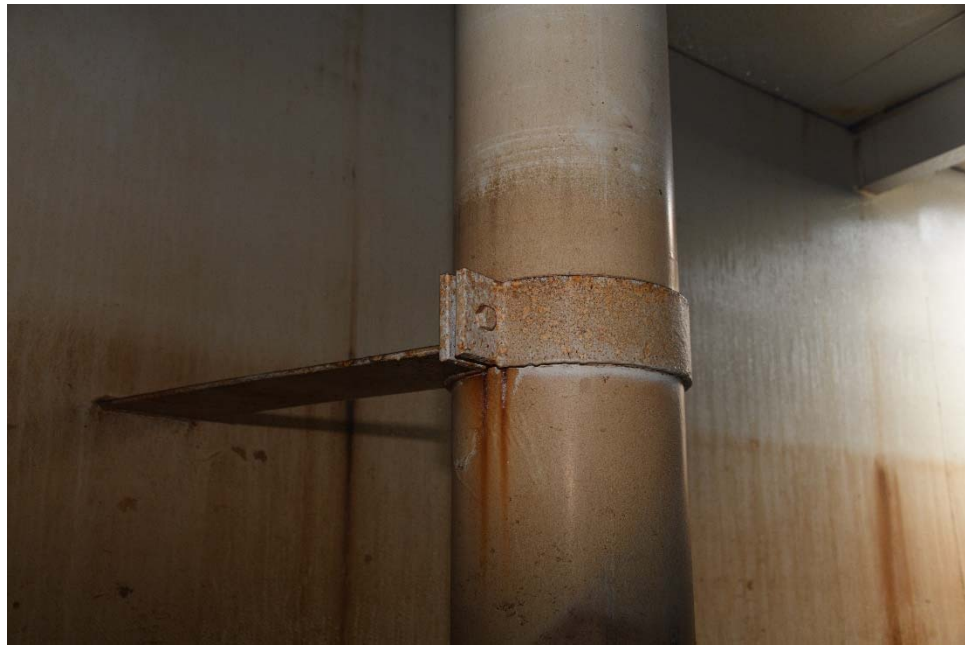
I-24 View of the liquid level indicator (LLI) roof penetrations, illustrating minor corrosion on the interior of the penetrations.

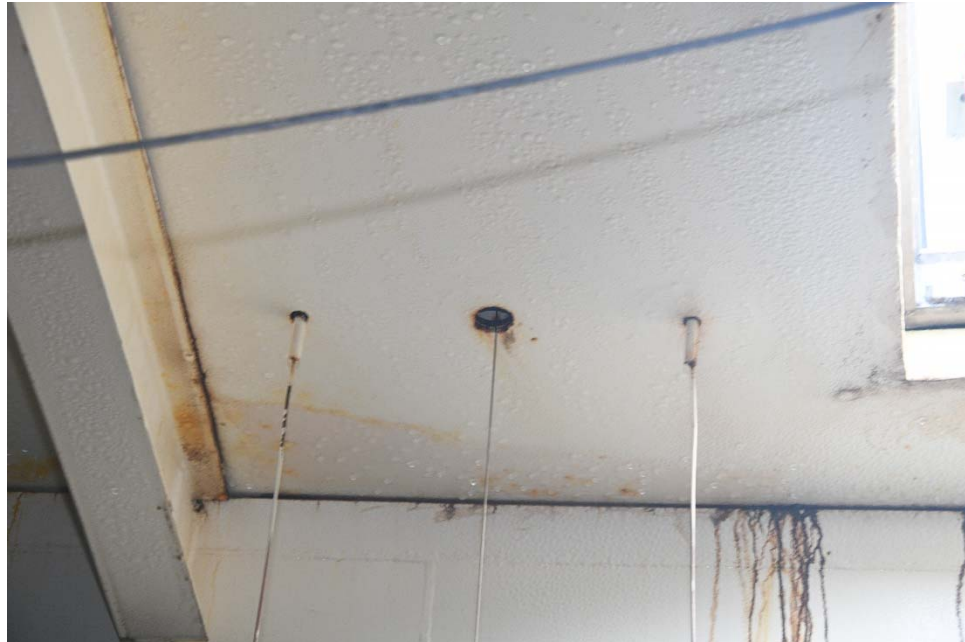
I-25 View of the LLI float, illustrating good condition of the float and guide wires.

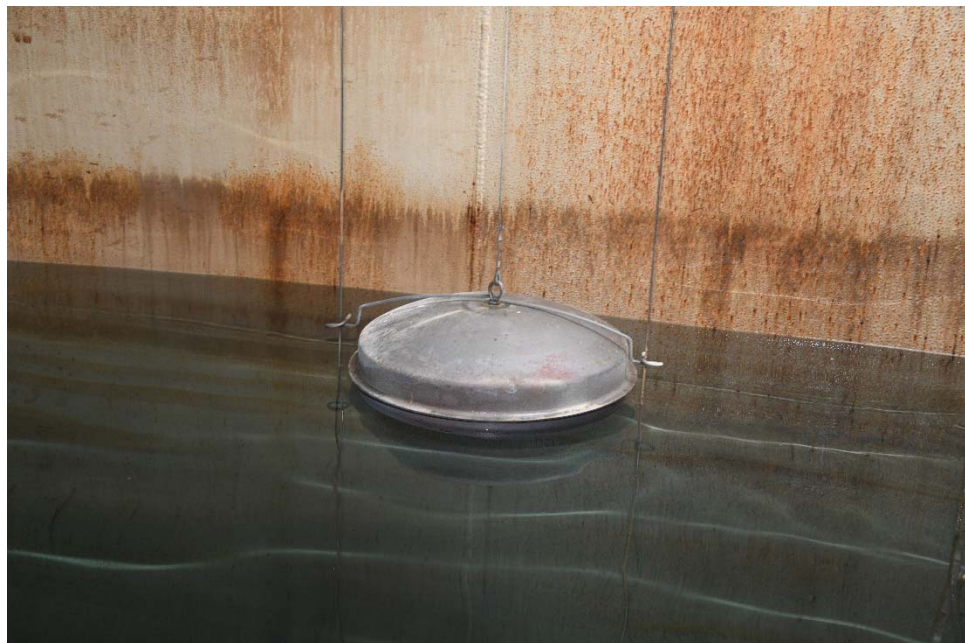
I-26 View of the roof hatch, illustrating minor corrosion along the perimeter of the hatch opening.

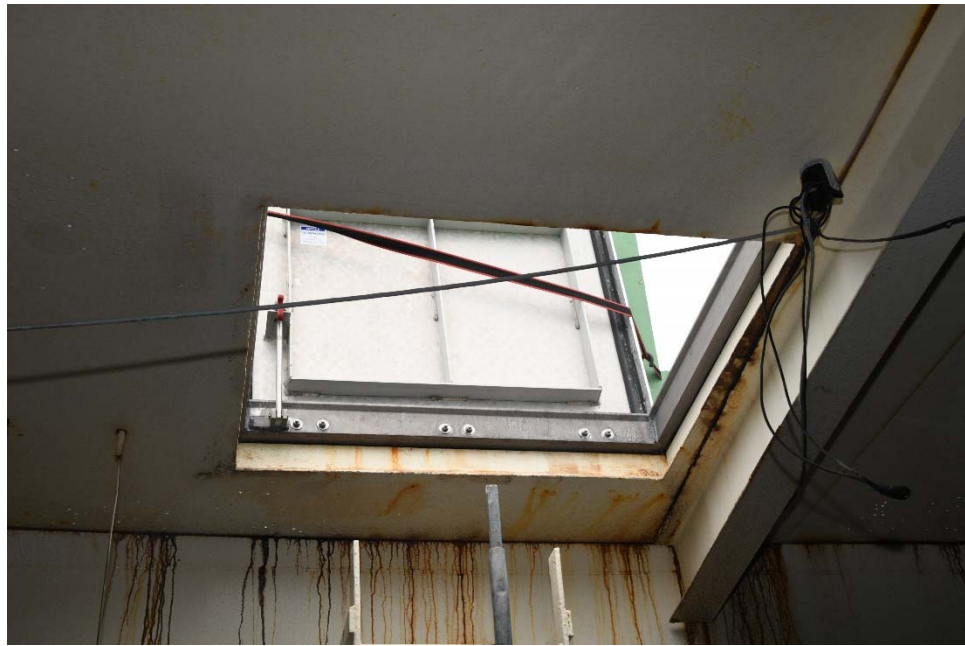
I-27 View of the shell at the ladder, illustrating dark staining on the shell and ladder and general corrosion on the shell.

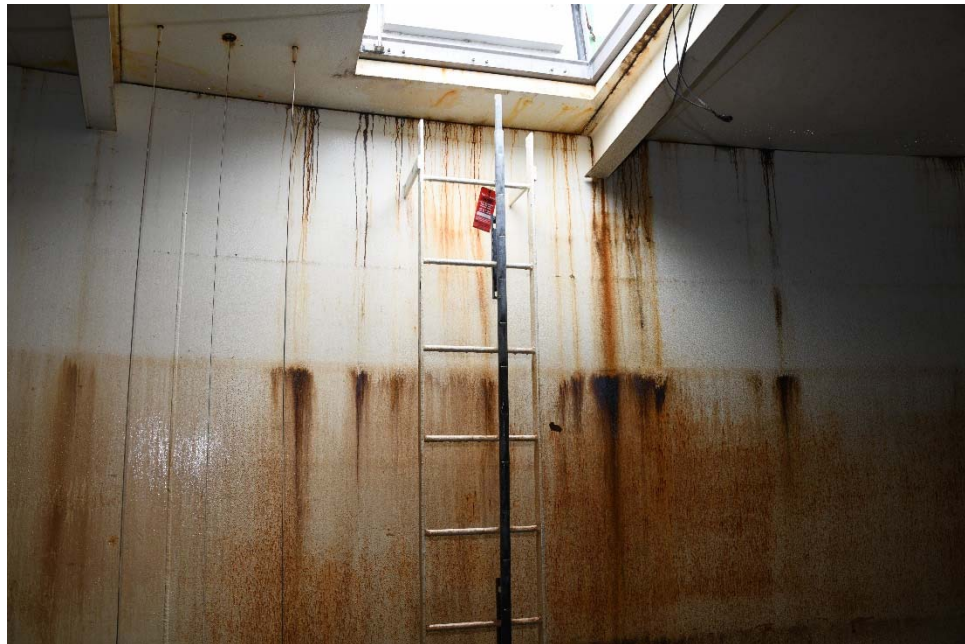
I-28 View of the ladder just below the waterline, illustrating blistering on the ladder side rails and the adjacent shell. Note corrosion in the popped blisters on the shell.

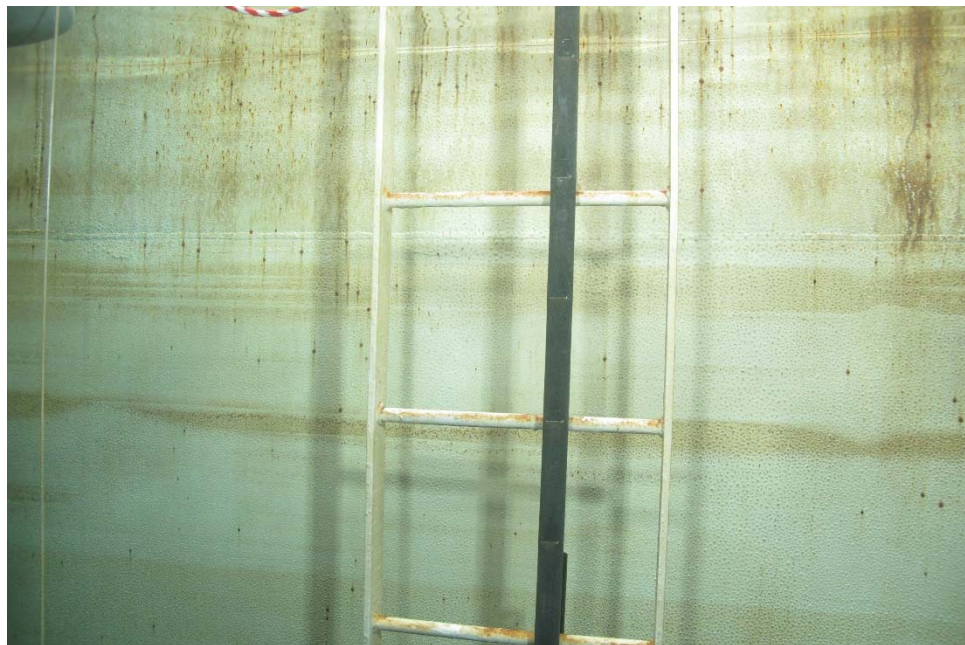
I-29 Same as Photo I-28, except further down the ladder.

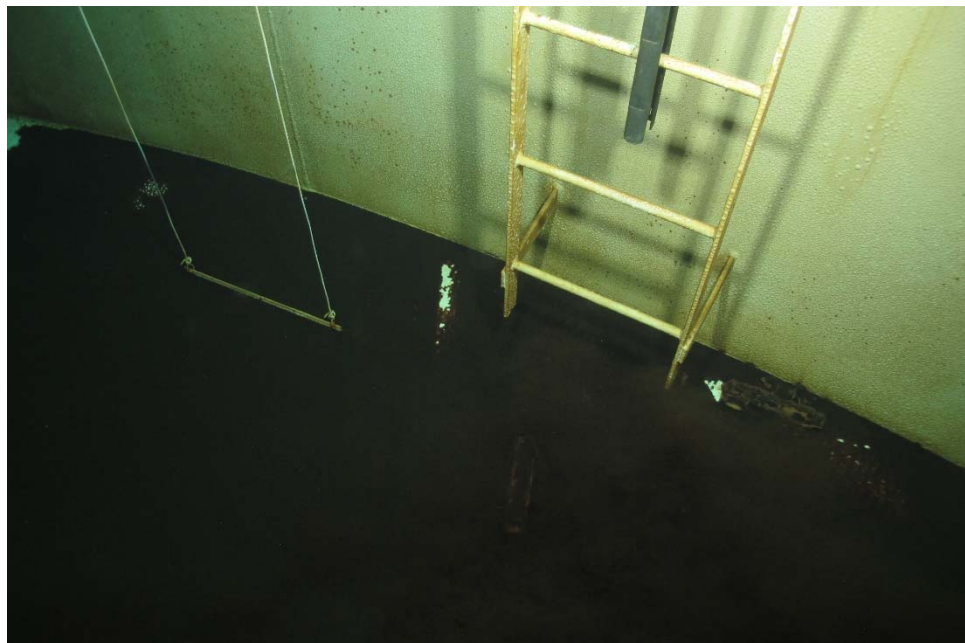
I-32 View of the shell, illustrating blistering of the coating system with numerous spots of corrosion.

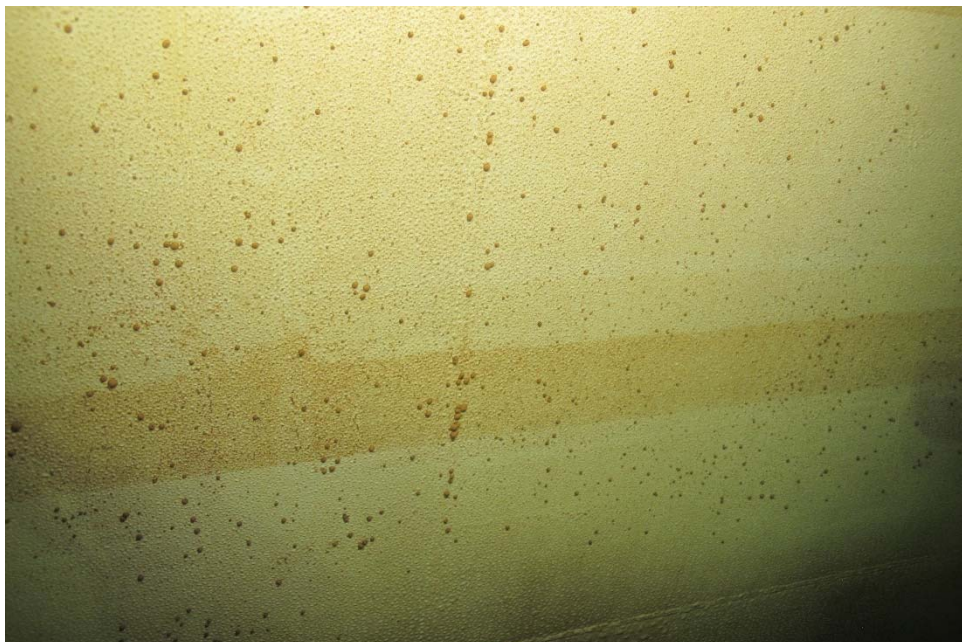
I-33 Same as Photo I-32, except in a different location.

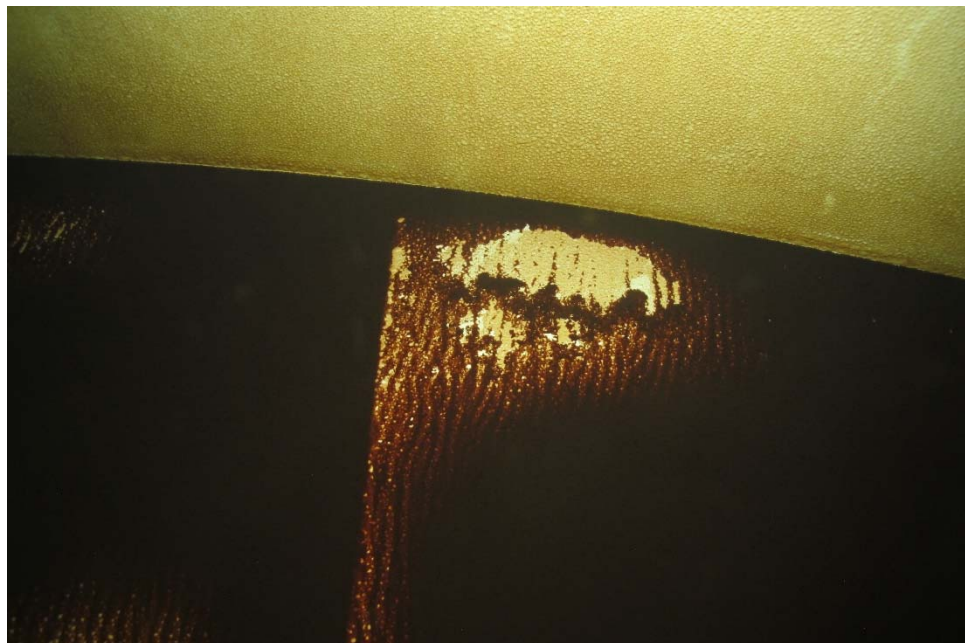
I-41 View of the column, illustrating blistering of the coating system with random spots of corrosion.

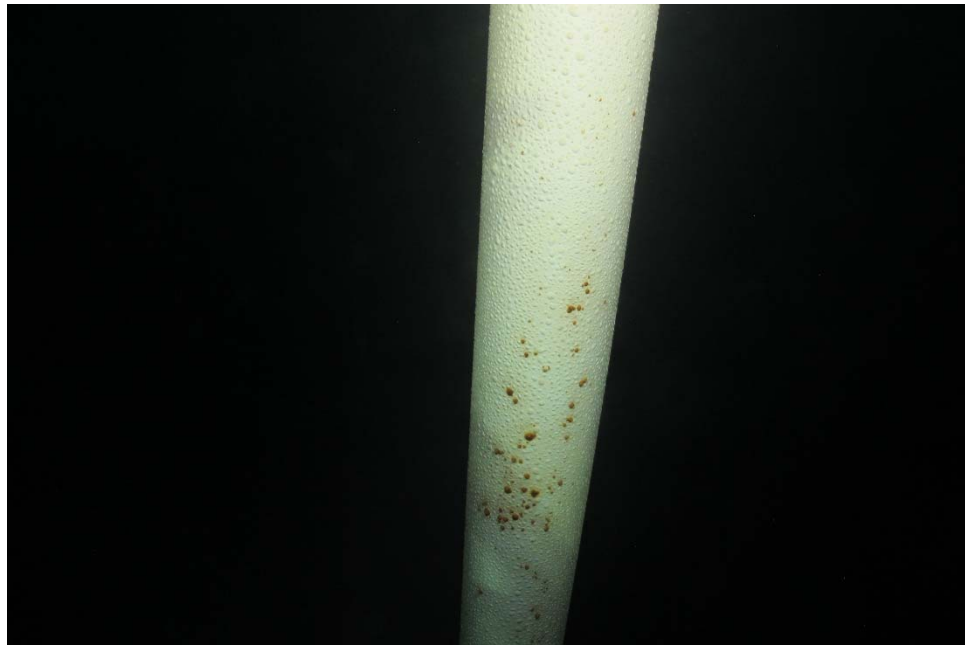
I-42 View of the column base, illustrating sediment on the base plate. Note blistering on the lower column.

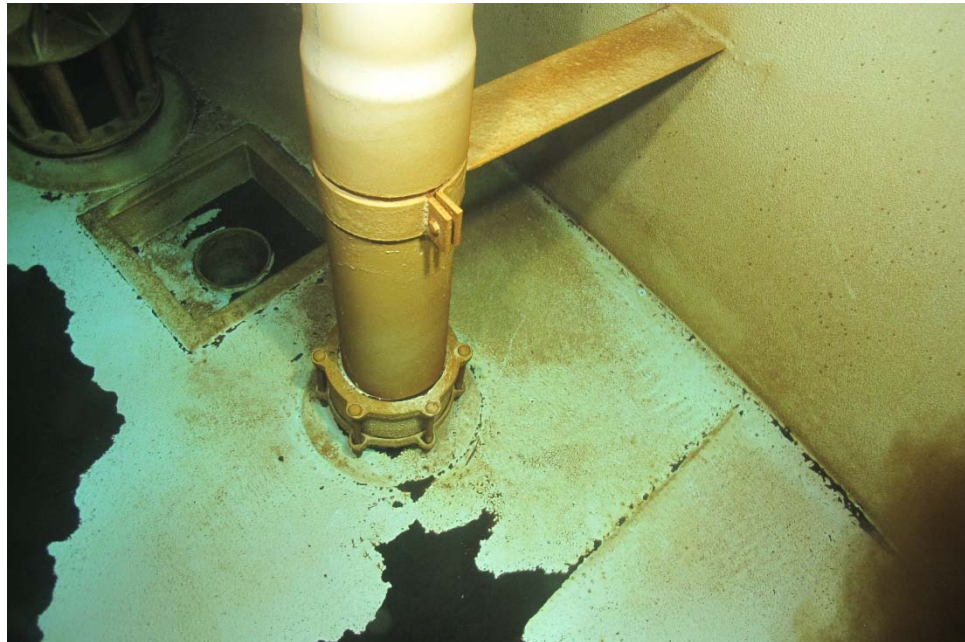
I-49 Same as Photo I-48, except further up the overflow. Note corrosion on the stand-off bracket.

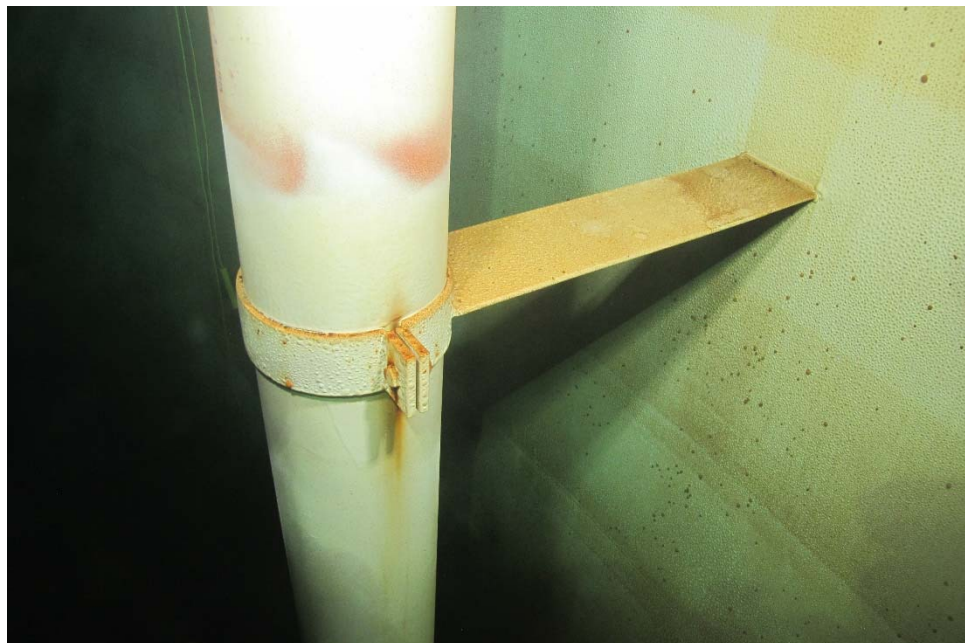
I-50 View of the drain sump and adjacent appurtenances, illustrating blistering of the coating system on all surfaces.

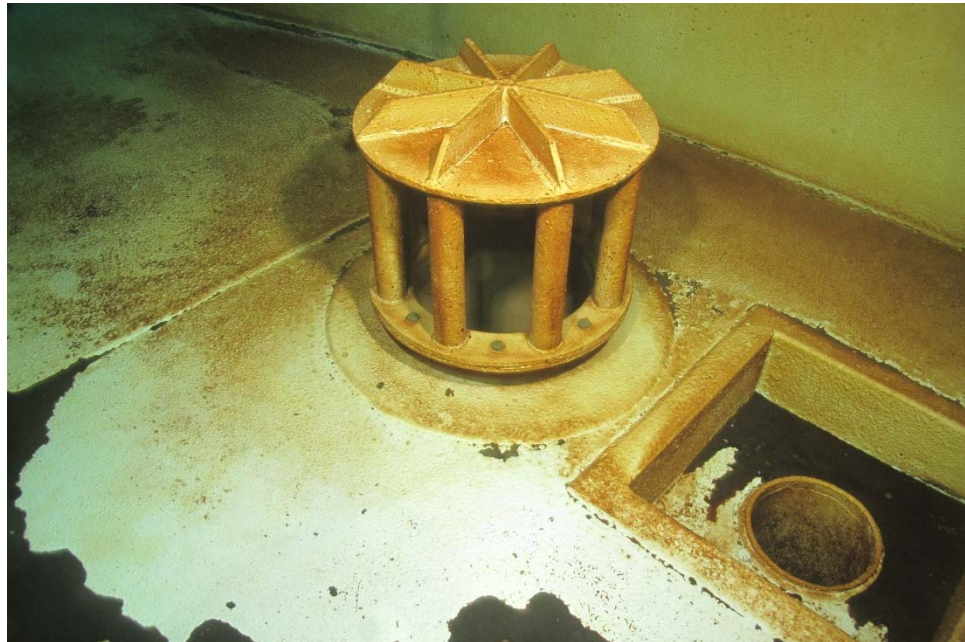
I-52 View of the LLI base, illustrating generally good condition of the base and guide wires.
